# Lewisham Arthouse

## Access Review

**Lewisham Arthouse**  
**140 Lewisham Way, London**  
**SE14 6PD**

**Date:** 1<sup>st</sup> March 2018

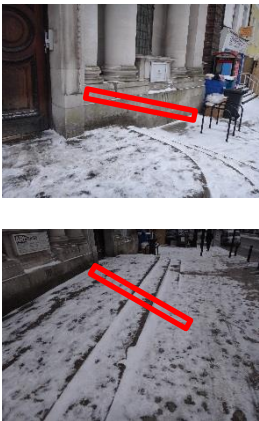
| No. | Location | Access Considerations | Photo | Access Guidance | Recommendations | Priority | £ |
|---|---|---|---|---|---|---|---|
| 5 | Entry Steps | These steps do not have handrails. | | A handrail should be provided on each side of a ramp or stair flight, throughout its length (including intermediate landings where this does not obstruct the use of adjoining access routes). The top surface of the handrail should be between 900mm and 1000mm from the surface of the ramp or pitch line of a stair and between 900mm and 1100mm from the landing. | It is recommended that at least two handrails are fitted to these steps; one near the wall and another as indicated on the photo. | M | M |

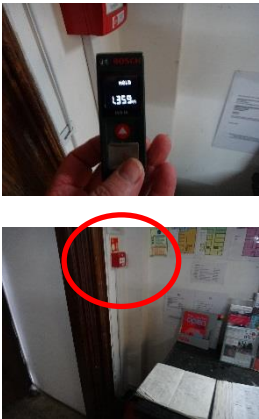
| No. | Location | Access Considerations | Photo | Access Guidance | Recommendations | Priority | £ |
|---|---|---|---|---|---|---|---|
| 9 | Fire Alarm Activation Points | The fire alarm activation point is positioned in the corner and is too high, preventing a wheelchair user from getting close enough to be able to reach it. | | Fire alarm activation points should be positioned between 1000mm and 1200mm above floor level and located at least 350mm from a corner, in a position making them accessible for wheelchair users to activate. | It is recommended that the fire alarm activation point is lowered and relocated away from the corner to make it accessible for wheelchair users to operate. | H | L |

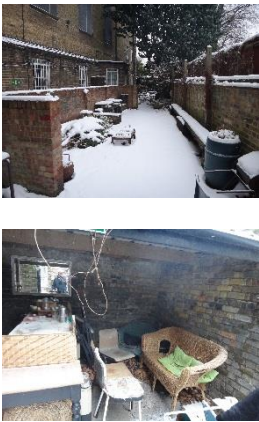
| No. | Location | Access Considerations | Photo | Access Guidance | Recommendations | Priority | £ |
|---|---|---|---|---|---|---|---|
| 44 | External Areas | There is no wheelchair access to this part of the garden area. Artists are allowed to use this area for socialising and encouraged to use it for their art. | | It would be considered reasonable for all members to have access to all of the Arthouse's facilities. | It is recommended that investigations are made into the introduction of an entrance into the garden through the shelter at the end of the garden, this could allow access for disabled members who wouldn't ordinarily have access to the garden. | M | H |

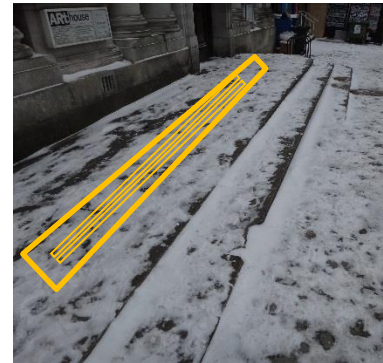
| | Option | Positive | Negative | Photo |
|---|---|---|---|---|
| 1 | Introduction of corduroy tactile paving at the top and bottom of the steps. | Will warn a pedestrian with a visual impairment of the steps | The top step is narrow. The corduroy paving at the top of the steps will cover much of the surface of the top step which is also the ramped route to the main entrance. The corduroy strips will run in the same direction as the direction a wheelchair user will travel, there is potential for a wheelchair user to get their wheels stuck in the grove and for them to be deflected towards the edge of the step. | |

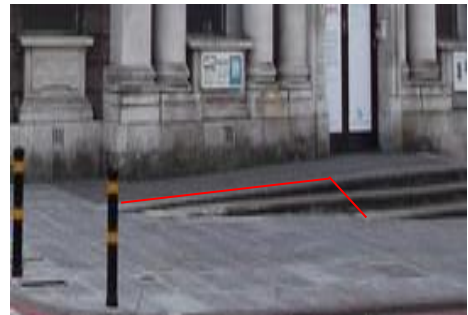
| 2 | Remove the tapered section of the steps and introduce handrails along the length of the ramp and edge of the steps. | This is probably the most effective way of eliminating the problem. | The cost to do this will be high. The look of the facade will be affected. Listed building consent may need to be granted. | |

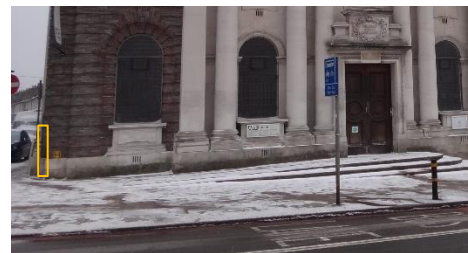
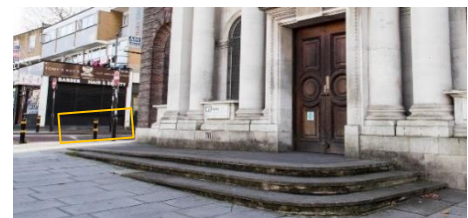
| 3 | Introduce a barrier/handrail at the corner of the building, perpendicular with the façade and near the start of the ramp, which would help to deflect/guide somebody with a visual impairment away from the ramp/steps. | This should have a positive result in guiding pedestrians to the main part of the pavement. | The introduction of additional street furniture can be confusing to some pedestrians. | |
