## QUINQUENNIAL INSPECTION REPORT with Recommendations for Repair

# LEWISHAM ARTHOUSE

First Quinquennial Inspection  
For Lewisham Arthouse

Dec 2023

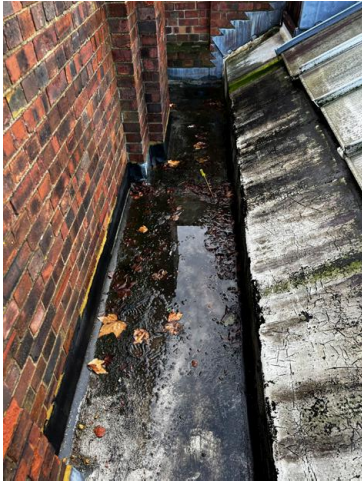
3.2 - Upstand crazing

- 3.15 The asphalt flat roof coating continues with the same details and defects as the N side. Repair is needed. (1)
- 3.16 The SE slope of the main rooflight falls against the tall parapet with a lead parapet gutter and three parapet outlets onto the narrow asphalt roof the other side. The lead appears to be in reasonable condition but is difficult to access for cleaning and maintenance due to the proximity of the roof light. Protection along the roof light would make access safer. (2)
- 3.17 A wide asphalt upstand to the base of this rooflight, exposed at either end where the tall parapet steps forward are crazing and should be refinished to prevent water ingress. It is likely the rooflight once extended over the upstand (image 3.2).

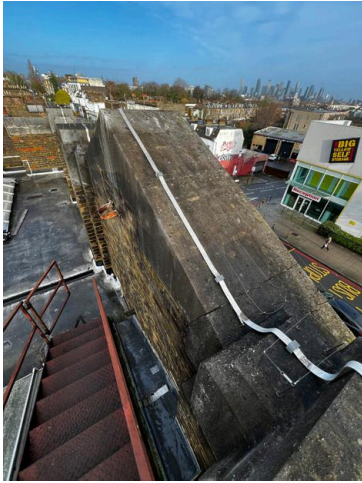
3.3 - Lead flashing

- 3.21 A lead flashing section to the NE end on the N slope has slipped down allowing water ingress, which has damaged the plaster internally. The lead should be released and refixed in position with stronger stainless steel clips (image 3.3). (U)

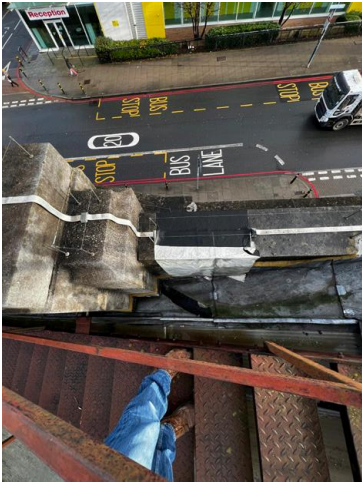
3.4 - Flashband detail

- 3.22 On the same slope just above the neighbouring brick pier the lead flashing has been repaired with flashband, which is not a robust repair and is most likely leaking judging by the ceiling decay directly below. This section of lead should be released and replaced if found to be split, allowing for thermal movement to prevent the same defect reoccurring (image 3.4). (U)

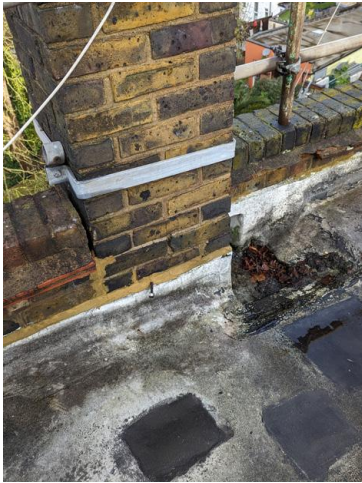
3.5 - Chimney/ parapet crack

- 3.36 A large crack between the first chimney stack and the parapet brick coping extends into the brickwork below. Although the brickwork has been pointed with what appears to be a cementitious mortar, the whole needs to be raked out and pointed with a lime mortar (image 3.5). (2)

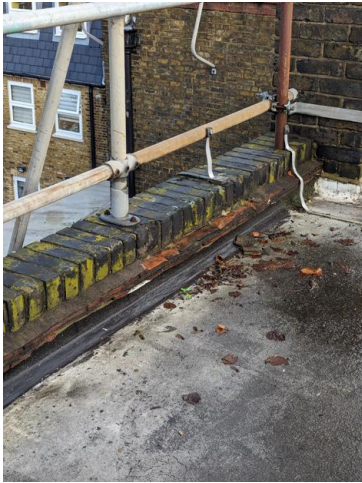
3.6 - Creasing tiles/ mortar fillet

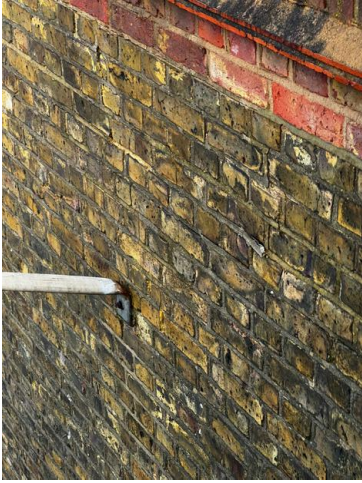
3.7 - Damaged cement fillet

- 3.39 A vertical crack in the parapet seen in the return section facing SW approx. 1m away from the W corner, needs to be pointed. (2). Externally the damaged cement fillet to the creasing tile is throwing water back into the wall (image 3.7). This is also related to the external defects on this section of wall, described in section 5 below.

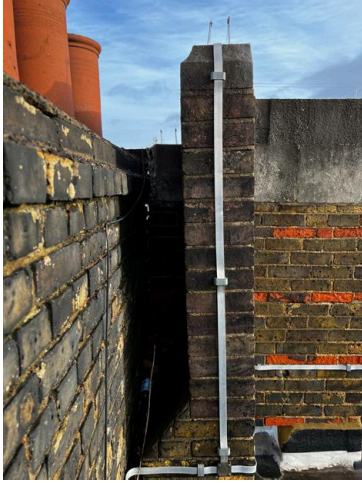
3.8 - Chimney/ parapet gap

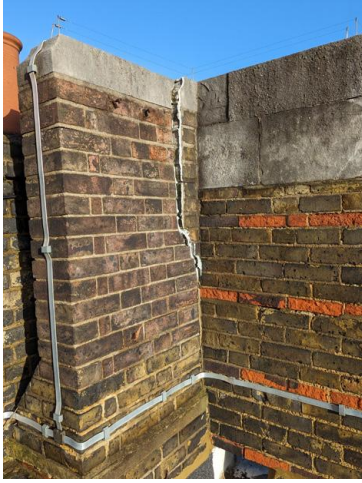
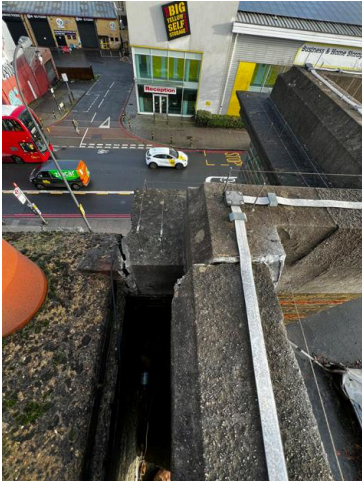
- 3.49 The single skin wall is cracked away from the main front section of the parapet and leans outwards towards the chimney stack (images 3.9 and 3.10). There are also three rusting iron fixings in this wall, the bottom one might well be contributing the masonry failure. As the wall returns onto the much more substantial section of the NE front parapet, it may be possible to remove the wall and improve the weathering detail. A structural engineer should be consulted. (2)

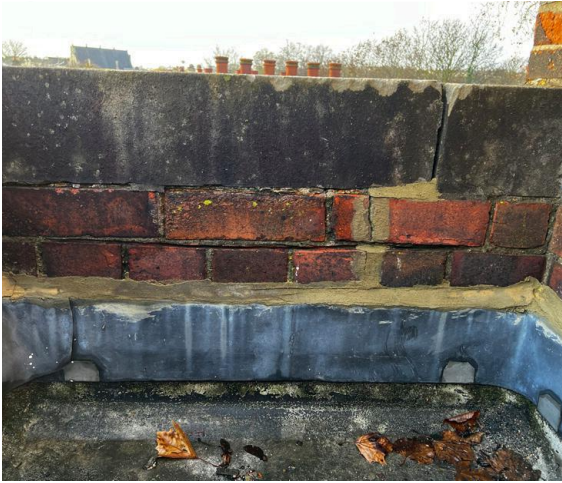
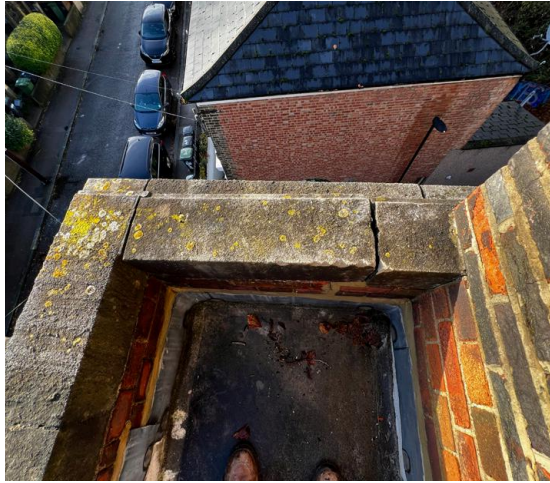
3.13 - Low parapet movement

3.14 - Low parapet movement

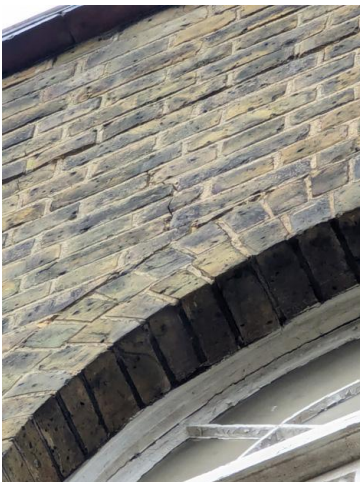
5.3 - NW elevation vertical cracking

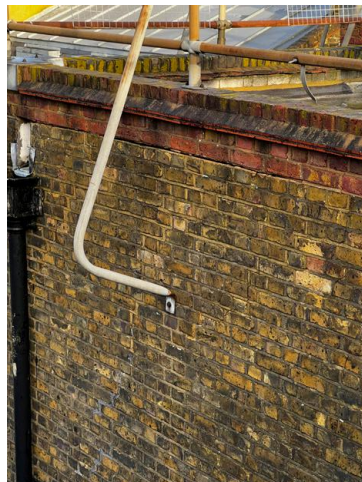
5.4 - Parapet jacking

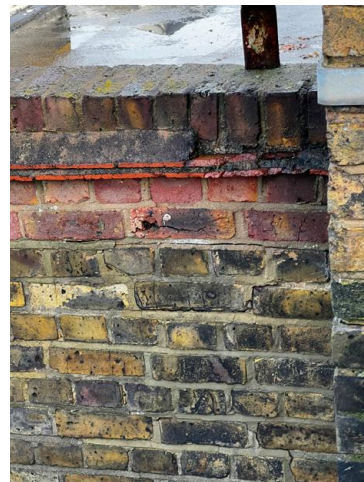
5.5 - Old scaffold tube fixing
