## QUINQUENNIAL INSPECTION REPORT with Recommendations for Repair

# LEWISHAM ARTHOUSE

First Quinquennial Inspection  
For Lewisham Arthouse

Dec 2023

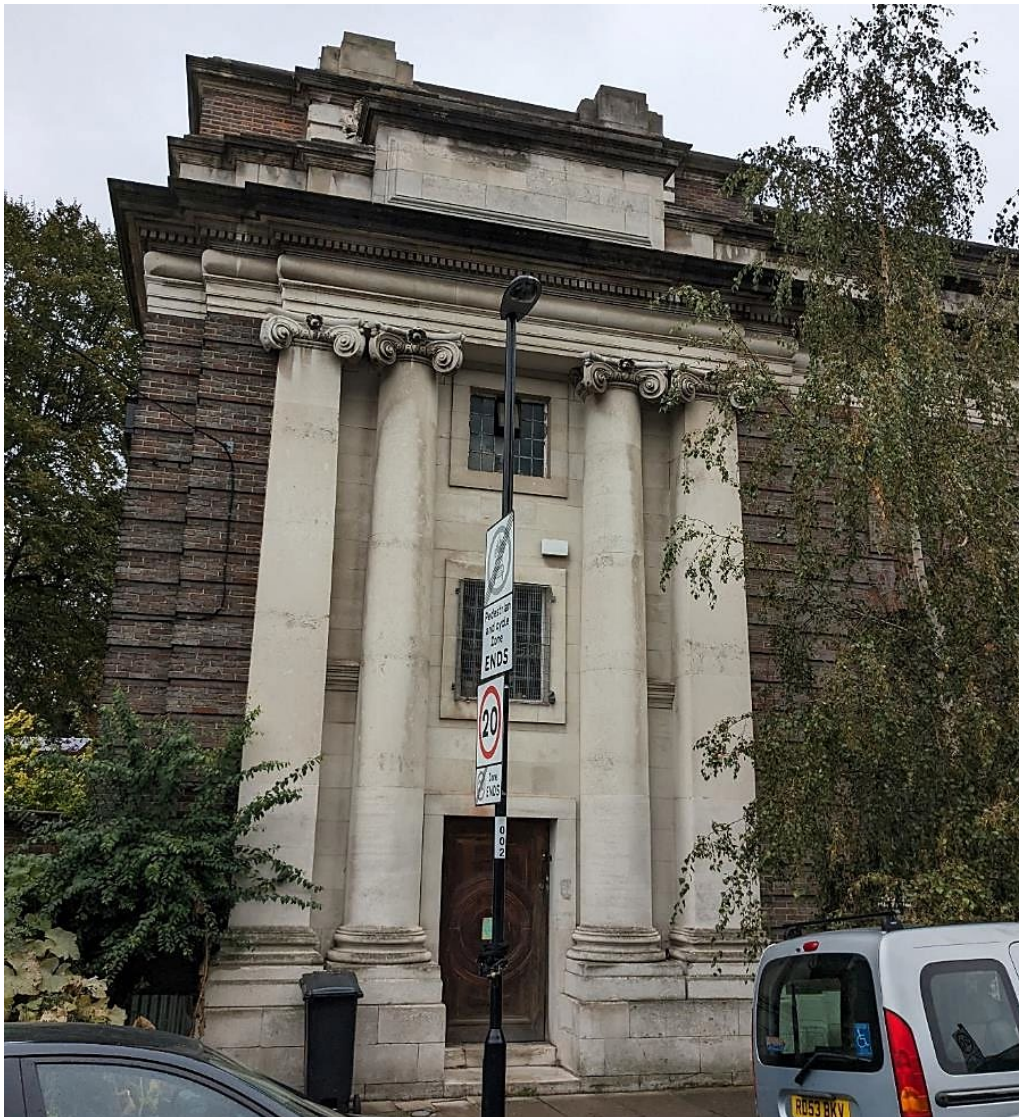
Fig. 4. South-east façade detail

- 5.23 The pulvinated cornice and blocking course continues on this elevation interrupted by a tympanum rising above the copings in the centre of the elevation. Above the end porticos there are projecting moulded stone panels also rising above the line of the blocking course. Fig. 4.

- 5.27 There are minor areas of stone decay and damage in the lower sections of the wall. The base of the pilaster to the NE corner is eroded and exfoliating, the top section of the plinth below the adjacent column eroded and repaired with cement. The corners of the sarcophagi below the central pediment are damaged but quite severely to the one on the LH side. All these areas would benefit from conservation. (5)

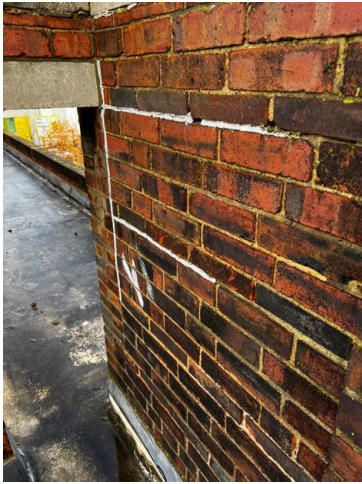
3.11 - Mastic filled joints

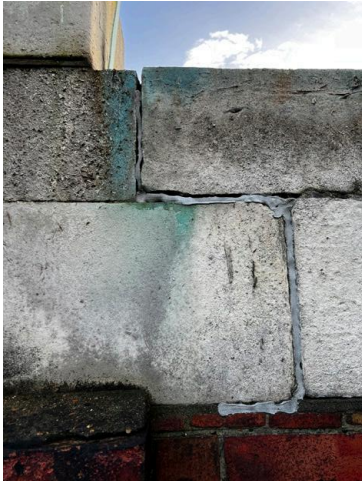
3.12 - Mastic filled joints

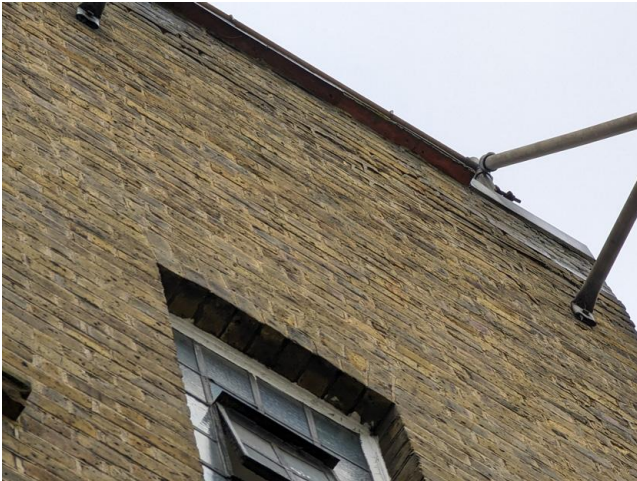
5.1 - SW facet of staircase wall

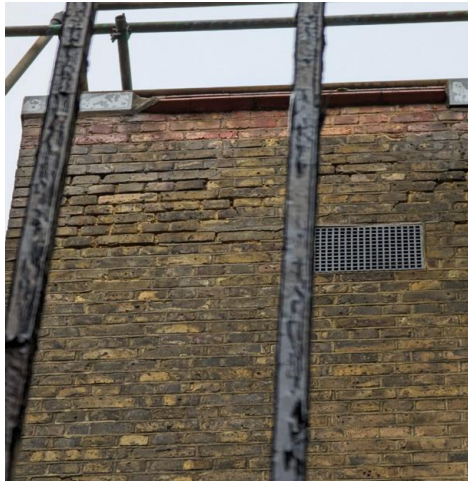
5.2 - SW facet of staircase wall

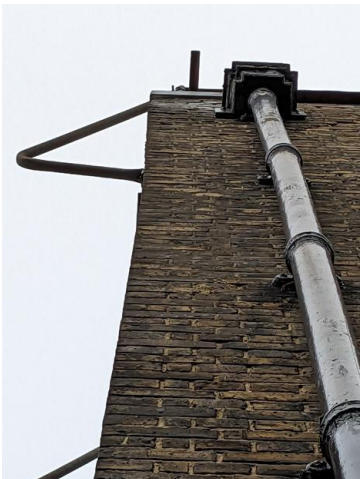
5.6 - West corner of staircase wall

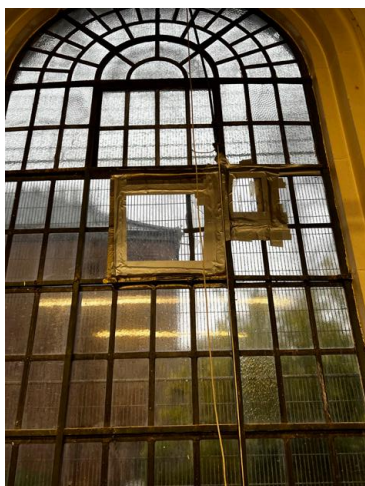
6.1 - Glazing in room 30 (studio)

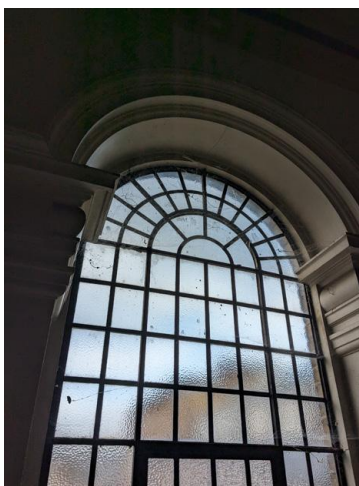
6.3 - Glazing in room 32 (staircase)

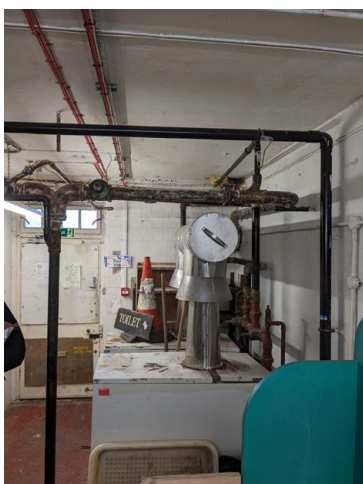
7.5 - Room 5 boiler and door

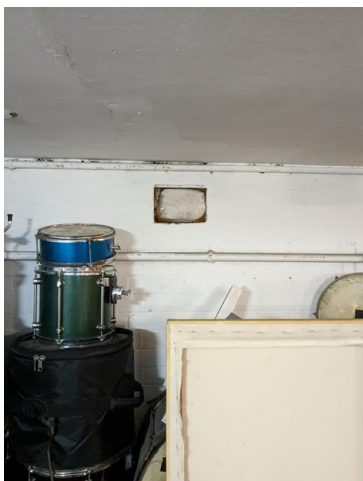
7.8 - Room 9 wall opening and soffit

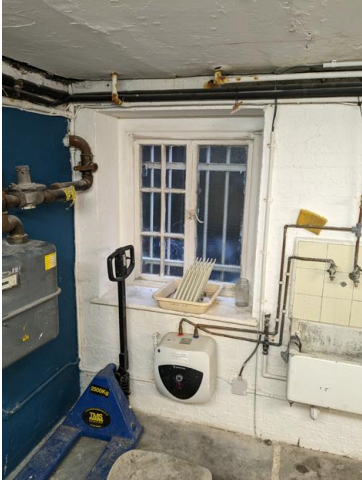
7.13 - Room 10 soffit and window

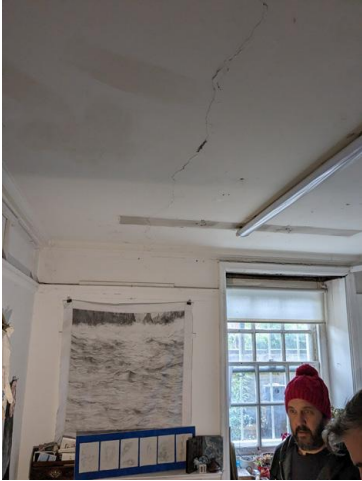
7.16 - Room 21 window and soffit

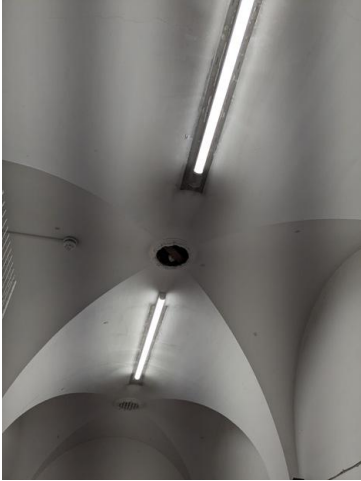
7.18 - Room 20 vaulted ceiling

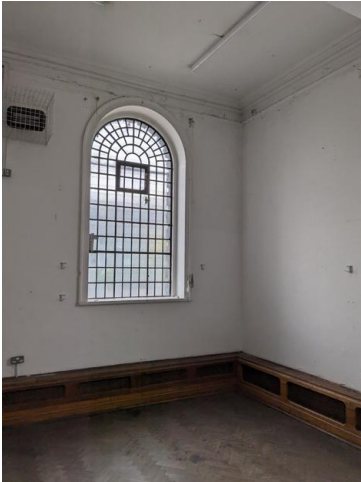
7.20 - Room 21 western corner

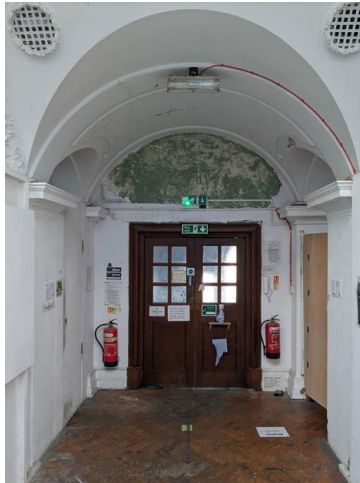
7.61 - Room 34 side vaults

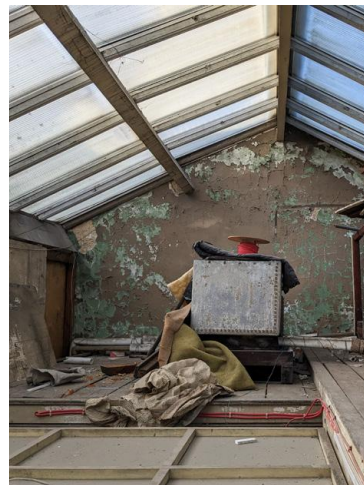
7.65 - Room 34 above barrel vault

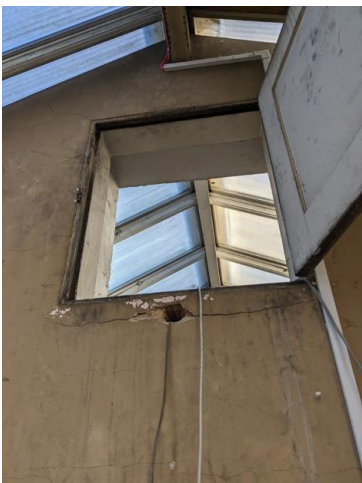
7.66 - Room 35 attic space

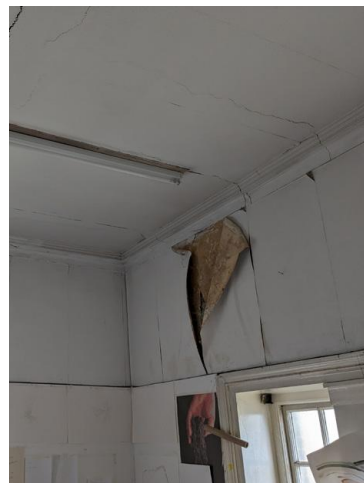
7.68 - Room 35 walls by room 36

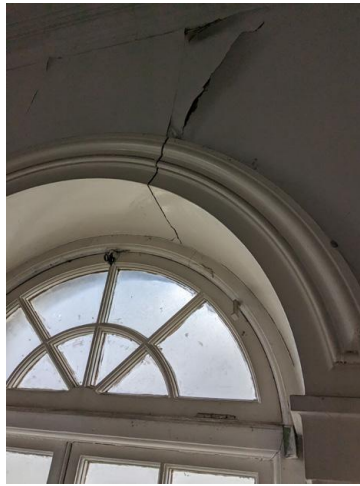
7.70 - Room 36 south-west edge

| Ref. | Description | Quantity | Unit | Rate | Sub-Total | Preliminaries @ 10% | O, H & P @ 10% | Contingency @ 10% | Total (excl VAT) |
|---|---|---|---|---|---|---|---|---|---|
| 17.2.9 | Determine if water damage is current or historic in areas where it is identified (room 1 soffit, (LGF) rooms on SE façade adjacent to external pipework, in room 24 (Stairs) and vaulted soffit of room 26 (Main Room) GF and rectify the issues if so, prior to any repairs to the surface finishes (7.26, 7.41, 7.57, 7.60, 7.68, 7.70, 7.71, 7.121, 7.124) | | | | | | | | |

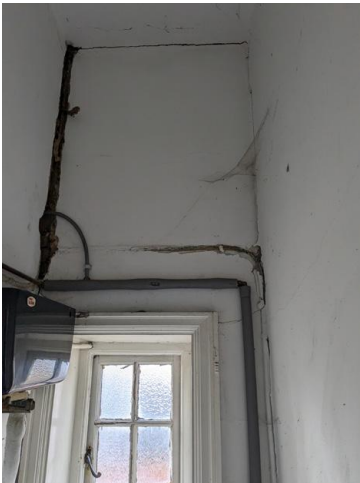
7.72 - Room 36 wallpaper and plaster

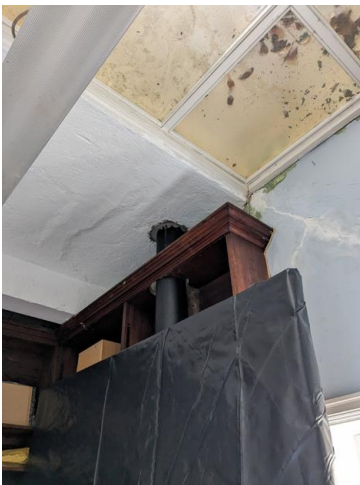
7.75 - Room 37 walls

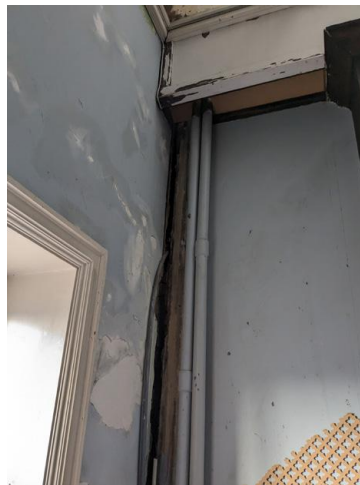
7.76 - Room 39 shelving and downpipe
