## QUINQUENNIAL INSPECTION REPORT with Recommendations for Repair

# LEWISHAM ARTHOUSE

First Quinquennial Inspection  
For Lewisham Arthouse

Dec 2023

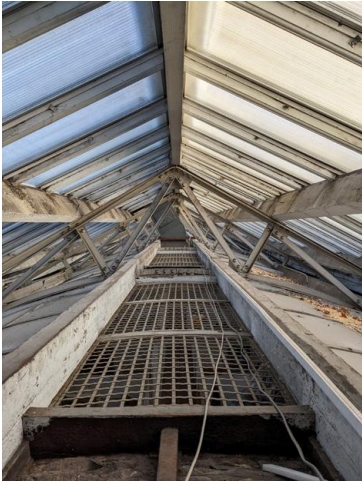
3.1 - Rooflight structure

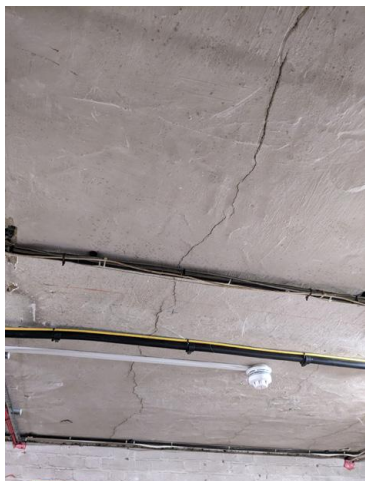
7.1 - Room 1 soffit

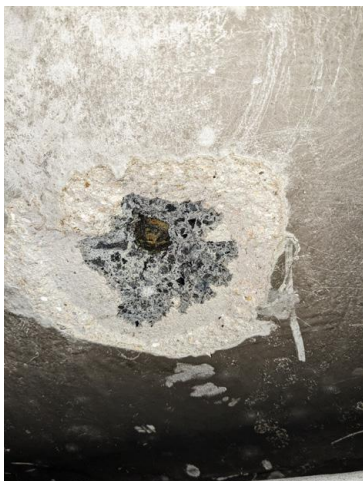
7.2 - Room 1 soffit

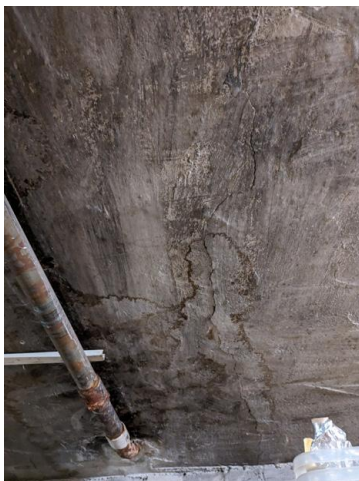
7.3 - Room 1 soffit

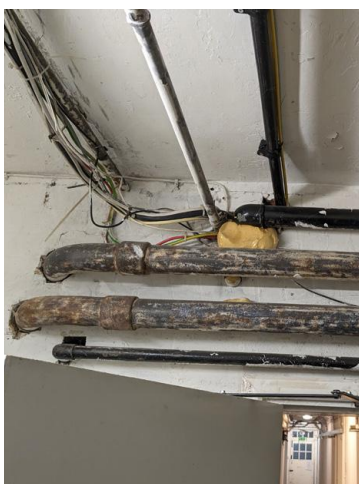
7.6 - Room 5 services

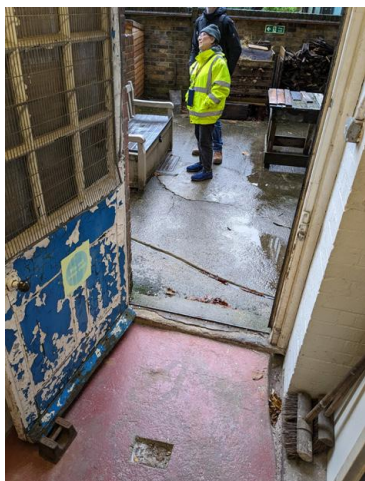
7.7 - Room 5 floor

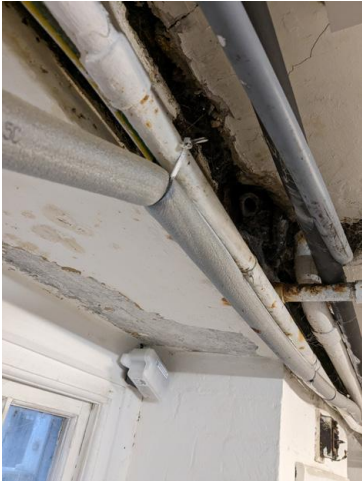
7.10 - Room 10 window area

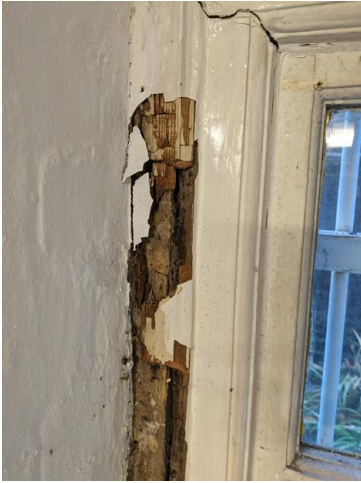
7.11 - Room 10 window

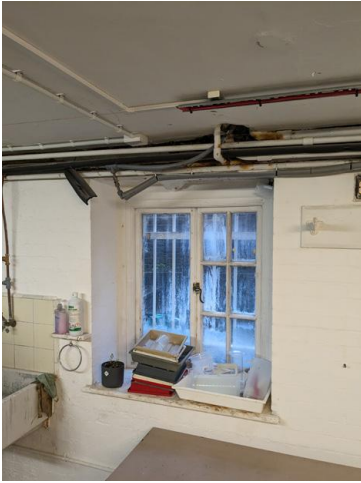
7.12 - Room 10 window

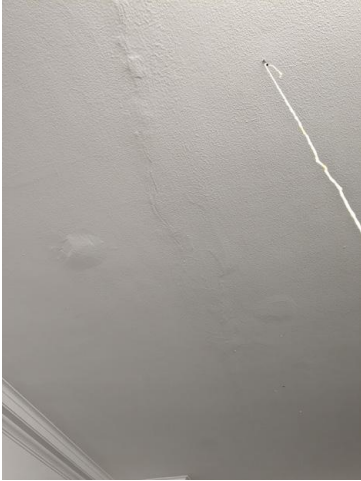
7.14 - Room 22 soffit

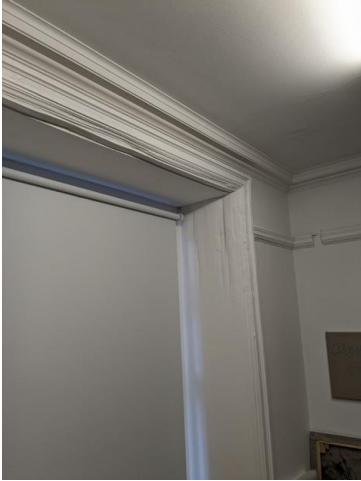
- 7.45 Window architraves are in some cases recently painted, however the timbers are warped (image 7.15), deformed or missing in areas (image 7.16) and there is evidence of rot. Consideration should be given to piece in repairs or the replacement of the frames. (2)
- 7.46 Windows in room 13 and 14 have been boarded up, likely due to broken panes. Consideration should be given to repair/ replacement of these windows. (2)
- 7.47 The partition between rooms 13 and 14 appears to be a more recent addition, built in blockwork and in acceptable condition.

7.15 - Room 22 architraves

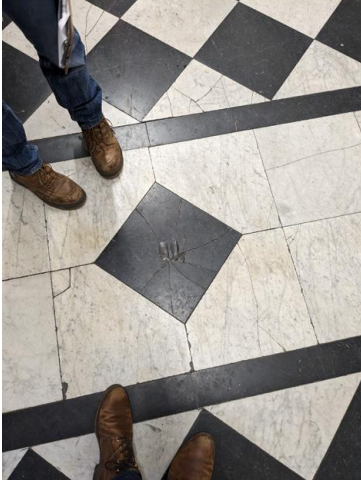
7.17 - Room 20 floor

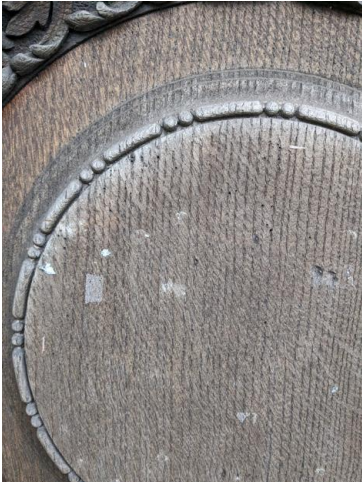
7.19 - Room 19 front door

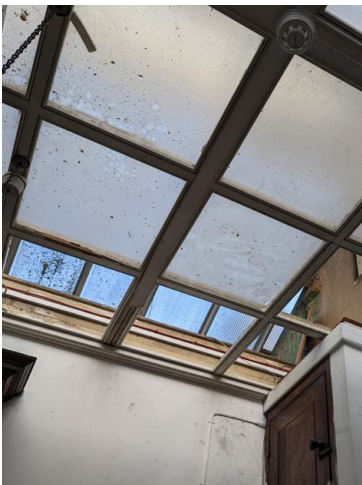
7.63 - Room 34 barrel vaulted roof

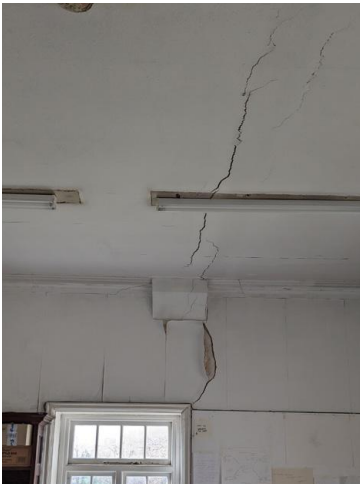
7.69 - Room 36 walls and soffit

| Ref. | Description | Quantity | Unit | Rate | Sub-Total | Preliminaries @ 10% | O, H & P @ 10% | Contingency @ 10% | Total (excl VAT) |
|---|---|---|---|---|---|---|---|---|---|
| 17.2.9 | Determine if water damage is current or historic in areas where it is identified (room 1 soffit, (LGF) rooms on SE façade adjacent to external pipework, in room 24 (Stairs) and vaulted soffit of room 26 (Main Room) GF and rectify the issues if so, prior to any repairs to the surface finishes (7.26, 7.41, 7.57, 7.60, 7.68, 7.70, 7.71, 7.121, 7.124) | | | | | | | | |

| Ref. | Description | Quantity | Unit | Rate | Sub-Total | Preliminaries @ 10% | O, H & P @ 10% | Contingency @ 10% | Total (excl VAT) |
|---|---|---|---|---|---|---|---|---|---|
| 17.2.11 | Obtain a copy of the latest electrical test report and ensure that items are addressed as per recommendations (7.70, 8.4) | | | Item | 500 | 50 | 55 | 61 | 666 |

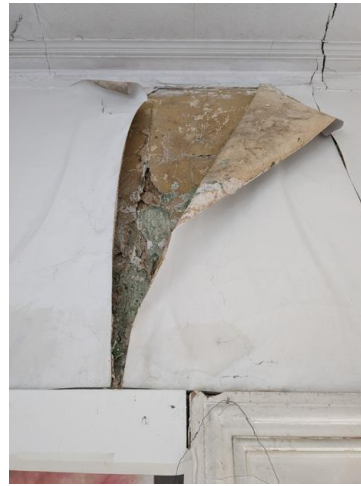
7.71 - Room 36 north-east edge

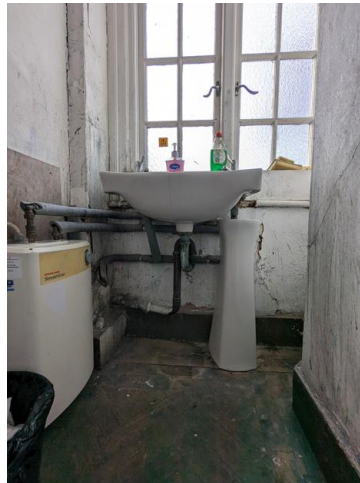
7.73 - Room 38 partitions and soffit

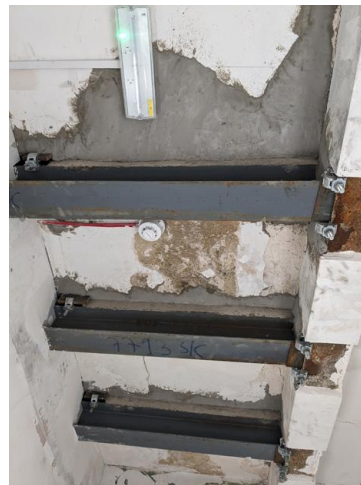
7.77 - Room 39 walls and partition
